NASA Technical Paper 1210

Light Airplane Crash Tests at Three Flight-Path Angles

Claude B. Castle and Emilio Alfaro-Bou

JUNE 1978

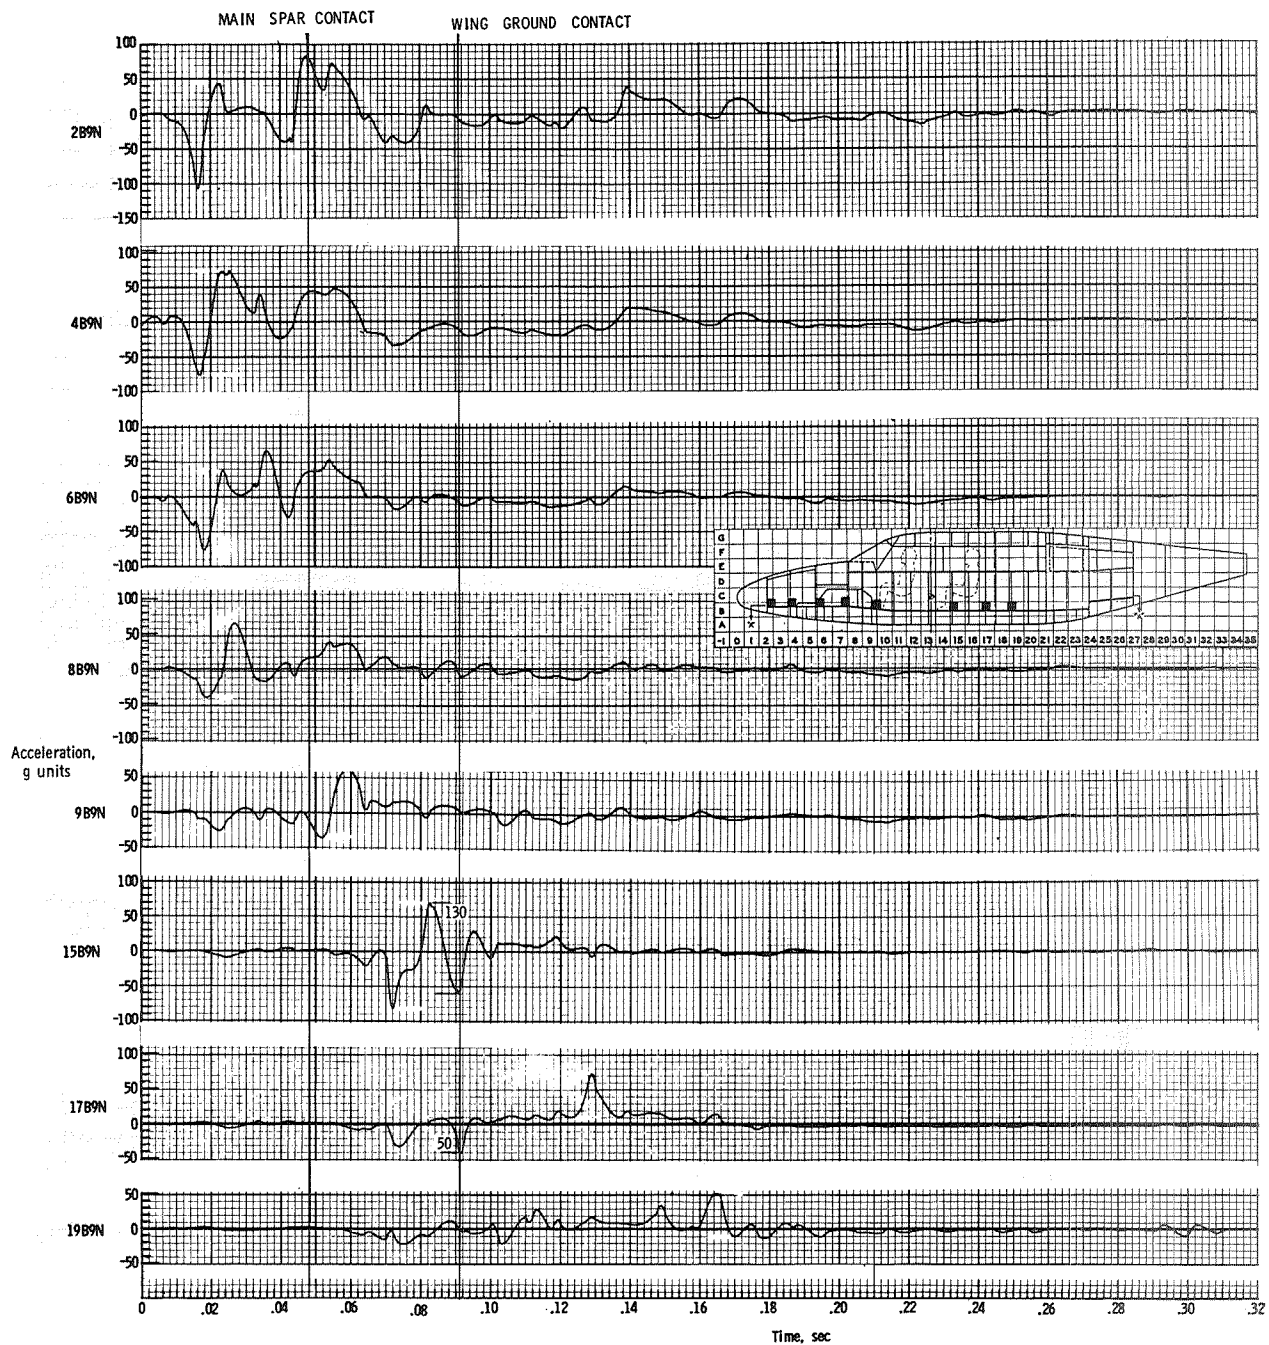
(a) -15° test specimen.

-15° test specimen.- In figure 18(a), eight acceleration time-history traces in the normal direction from the -15° impact are presented with timed events from photographic data superimposed on the traces for correlation and interpretation. The eight accelerometers are spaced along the floor beam of the airplane from the first nose frame (2B9N) to the door of the cabin (19B9N). The response of initial ground contact is felt immediately at the first frame (2B9N) and is seen to progress rearward to the instrument panel (9B9N), with diminishing intensity and with a slight time lag associated with the rear progression of the contact surface. The nose of the airplane exhibits high amplitude oscillatory behavior caused by the repeated sequence of negative accelerations. This oscillatory behavior is due to load transmission through structural failures and load build-up, thereby relieving load momentarily on undamaged structure and causing subsequent structural deceleration loading. This cycle is repeated as various structural elements are loaded and successively fail. Main spar ground contact (0.048 sec) produces a downward force in the nose of the airplane (positive acceleration) and signals the initiation of cabin compartment excitation. Acceleration peaks in the cabin compartment are a maximum in the vicinity of the main spar and diminish progressively from that point rearward. At 0.091 sec (fig. 18(a)) the loss of wing dihedral angle and wing ground contact occurs, thus resulting in the twisting of the main spar. At this time, peak-to-peak accelerations of 130g and 50g are produced in the first-passenger aisle seat legs (15B9N and 17B9N).

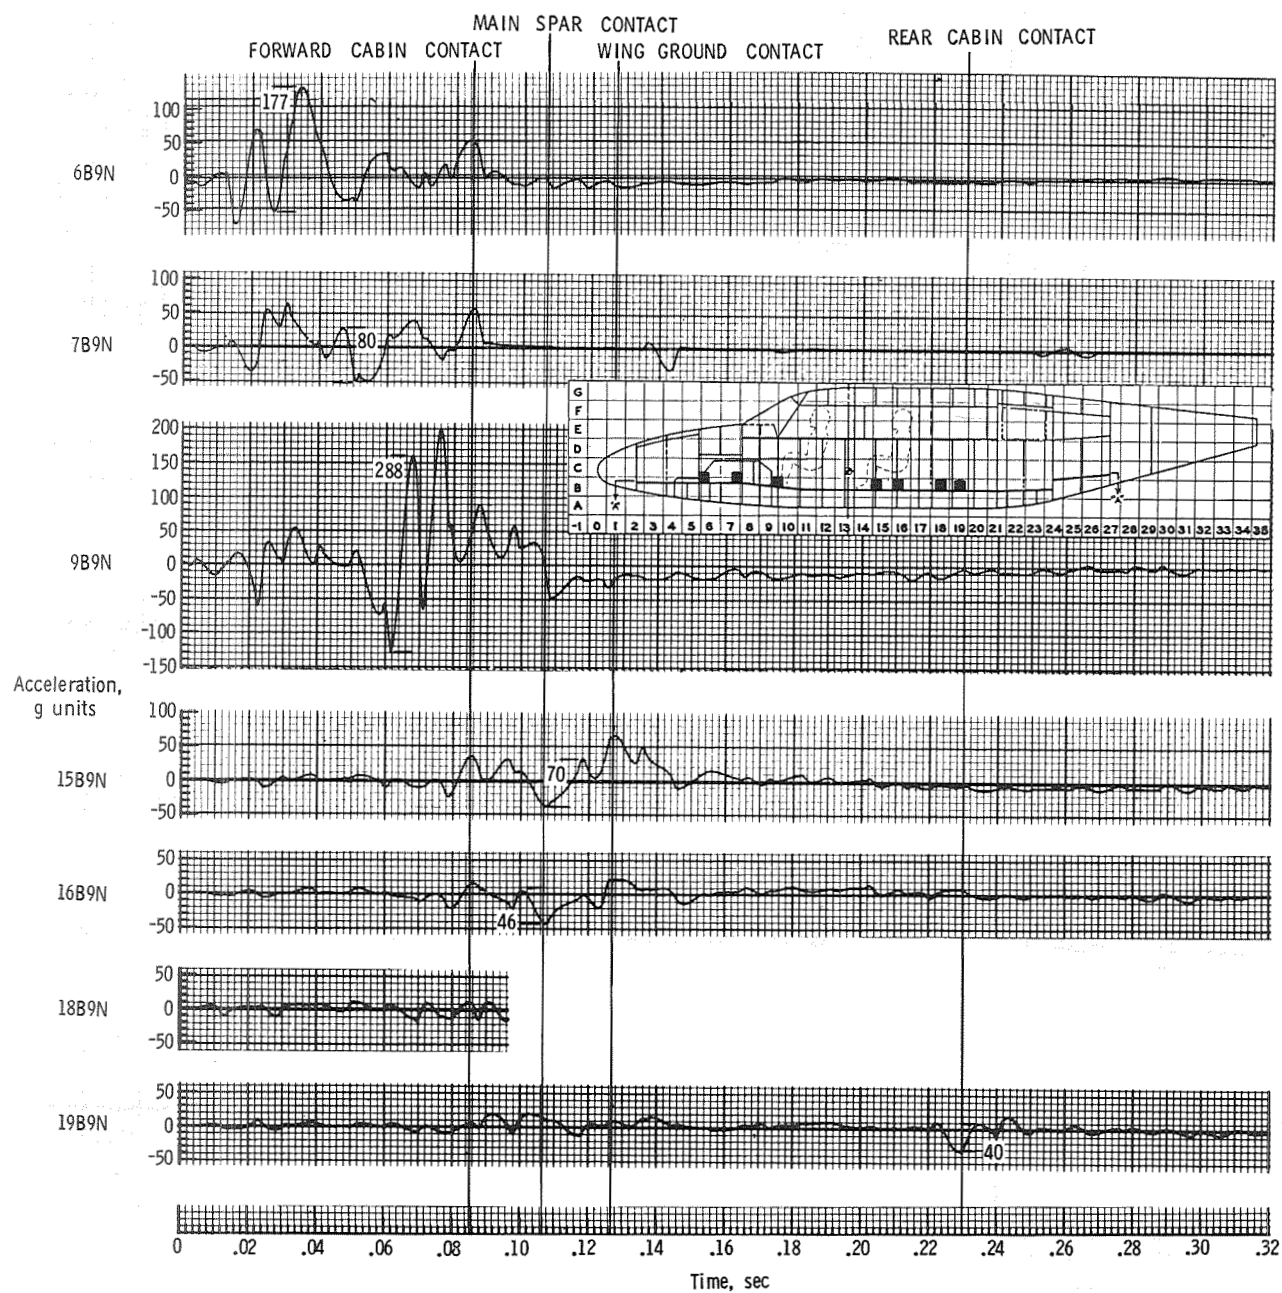
(b) -30° test specimen.

-30° test specimen.- Seven normal accelerations along the floor beam for the -30° impact are shown in figure 18(b). Accelerometer locations are similar to those of the -15° impact (fig. 8), except for the removal of the accelerometer from the middle of the luggage compartment in the nose of the airplane (4B9N at -15° impact). The response at initial ground contact in the nose of the airplane is severe and is seen to progress rearward to the instrument panel (9B9N) with diminishing intensity. The maximum peak-to-peak acceleration at the fire wall (9B9N) is 190 percent higher for the -30° impact than for the -15° impact.

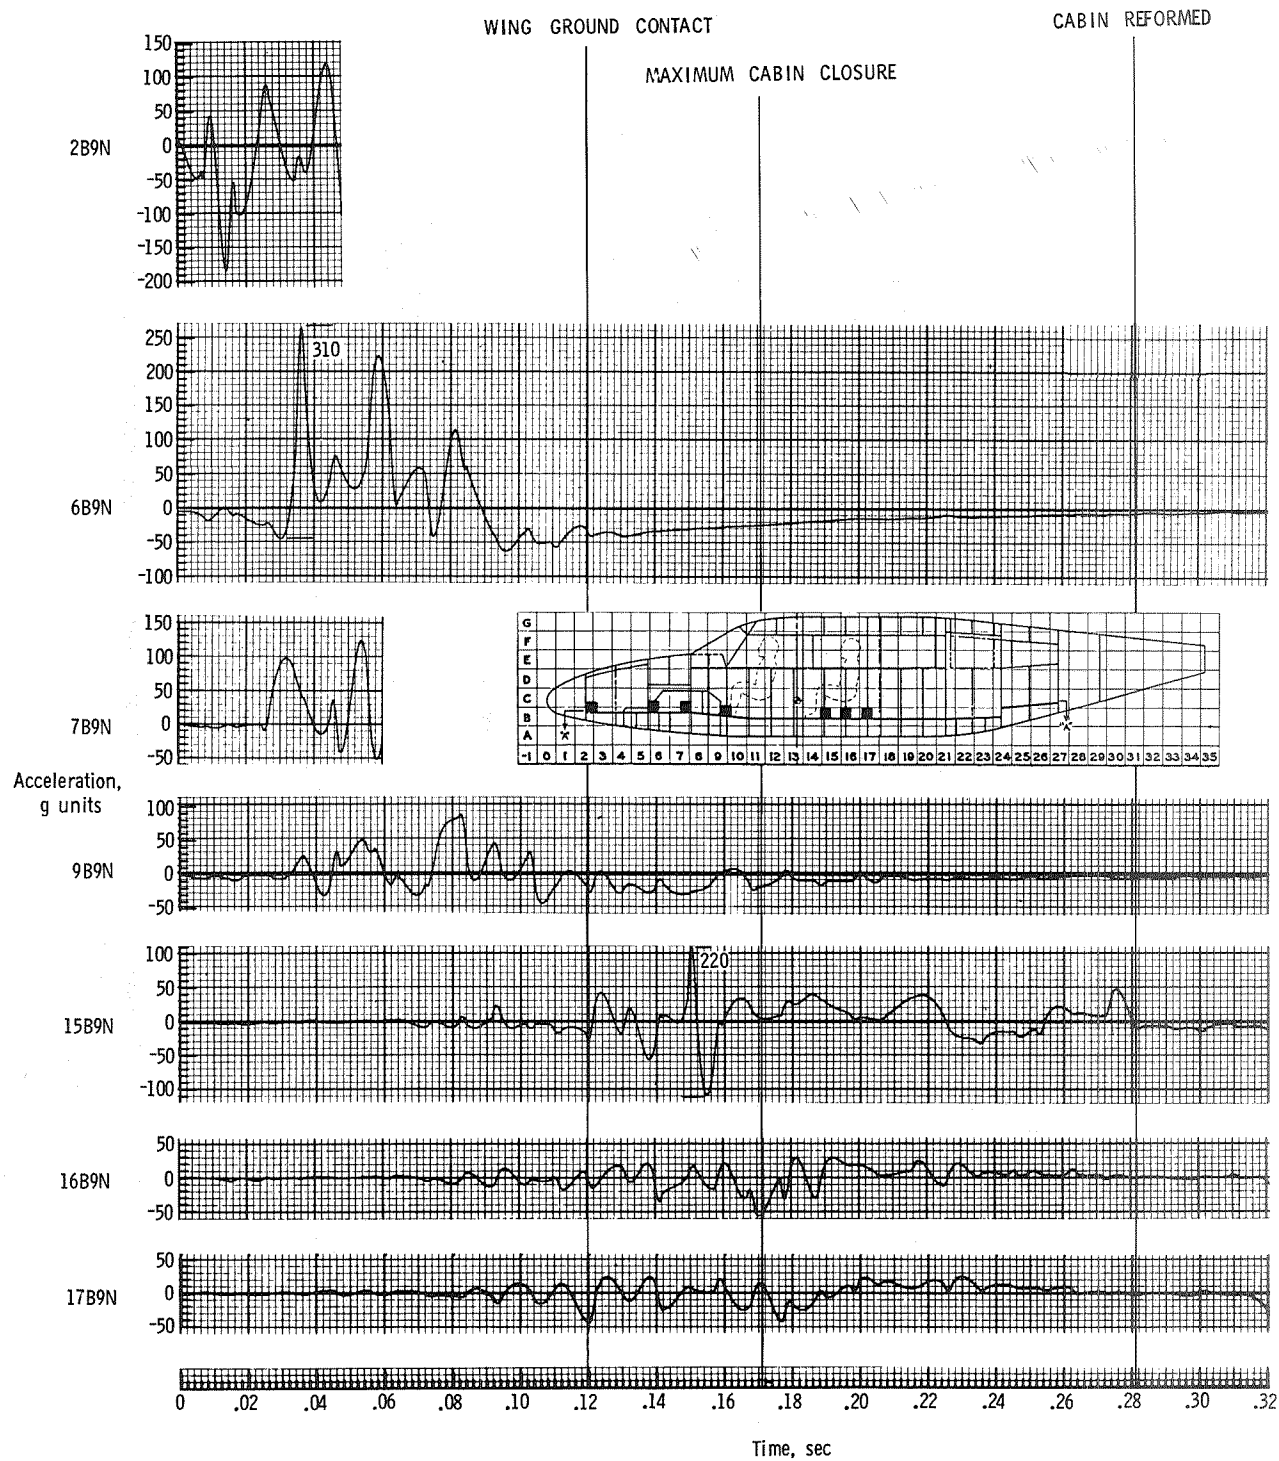
(c) -45° test specimen.

-45° test specimen.- Seven normal accelerations along the floor beam for the -45° impact are shown in figure 18(c). The accelerometer locations are similar to those of -30° impact (fig. 8). The response at initial ground contact in the nose of the airplane is most severe for the -45° impact; in fact, peak-to-peak accelerations as high as 310g are induced. On moving rearward after the progression of the impact pulse, the magnitudes of the acceleration decrease as some of the impact energy is absorbed by the nose structure and less difference in magnitude is evident between the -15°, -30°, and -45° acceleration traces in the cabin area of the three test specimens. Overall, the duration of accelerations is shorter and less severe in the -15° impact than in the -30° impact or in the -45° impact. (See figs. 18(a), 18(b), and 18(c).)

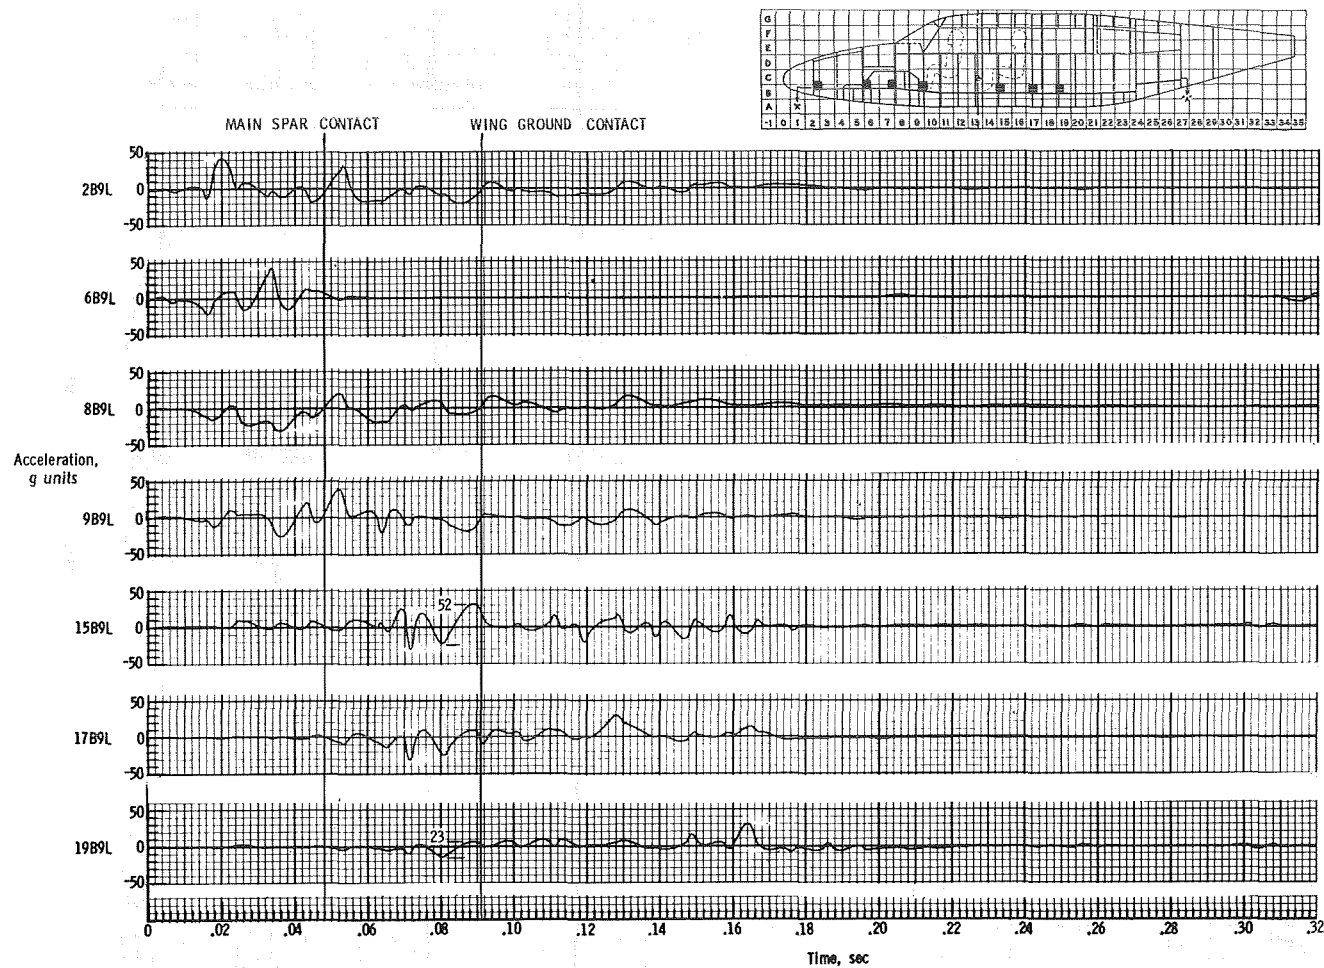
(a) -15° test specimen.

-15° test specimen.- Seven accelerometers (fig. 19(a)) are spaced along the floor beam of the airplane from the first nose frame (2B9L) to the rear of the passenger seat (19B9L). The response at initial ground contact is felt immediately at the first frame (2B9L), and contact progresses rearward to the instrument panel (9B9L) with diminishing intensity but with about half the acceleration magnitudes experienced in the normal direction. Similarly, a characteristic high-amplitude oscillatory behavior in the nose of the airplane in the vicinity of the main spar is again evident for the longitudinal accelerations as for the normal accelerations. Wing ground contact (second impact) is shown at 0.091 sec. The time at which fuselage separation occurred (across the cabin roof in the vicinity of the main spar) coincides with the positive acceleration peak in 17B9L and 19B9L at 0.164 sec.

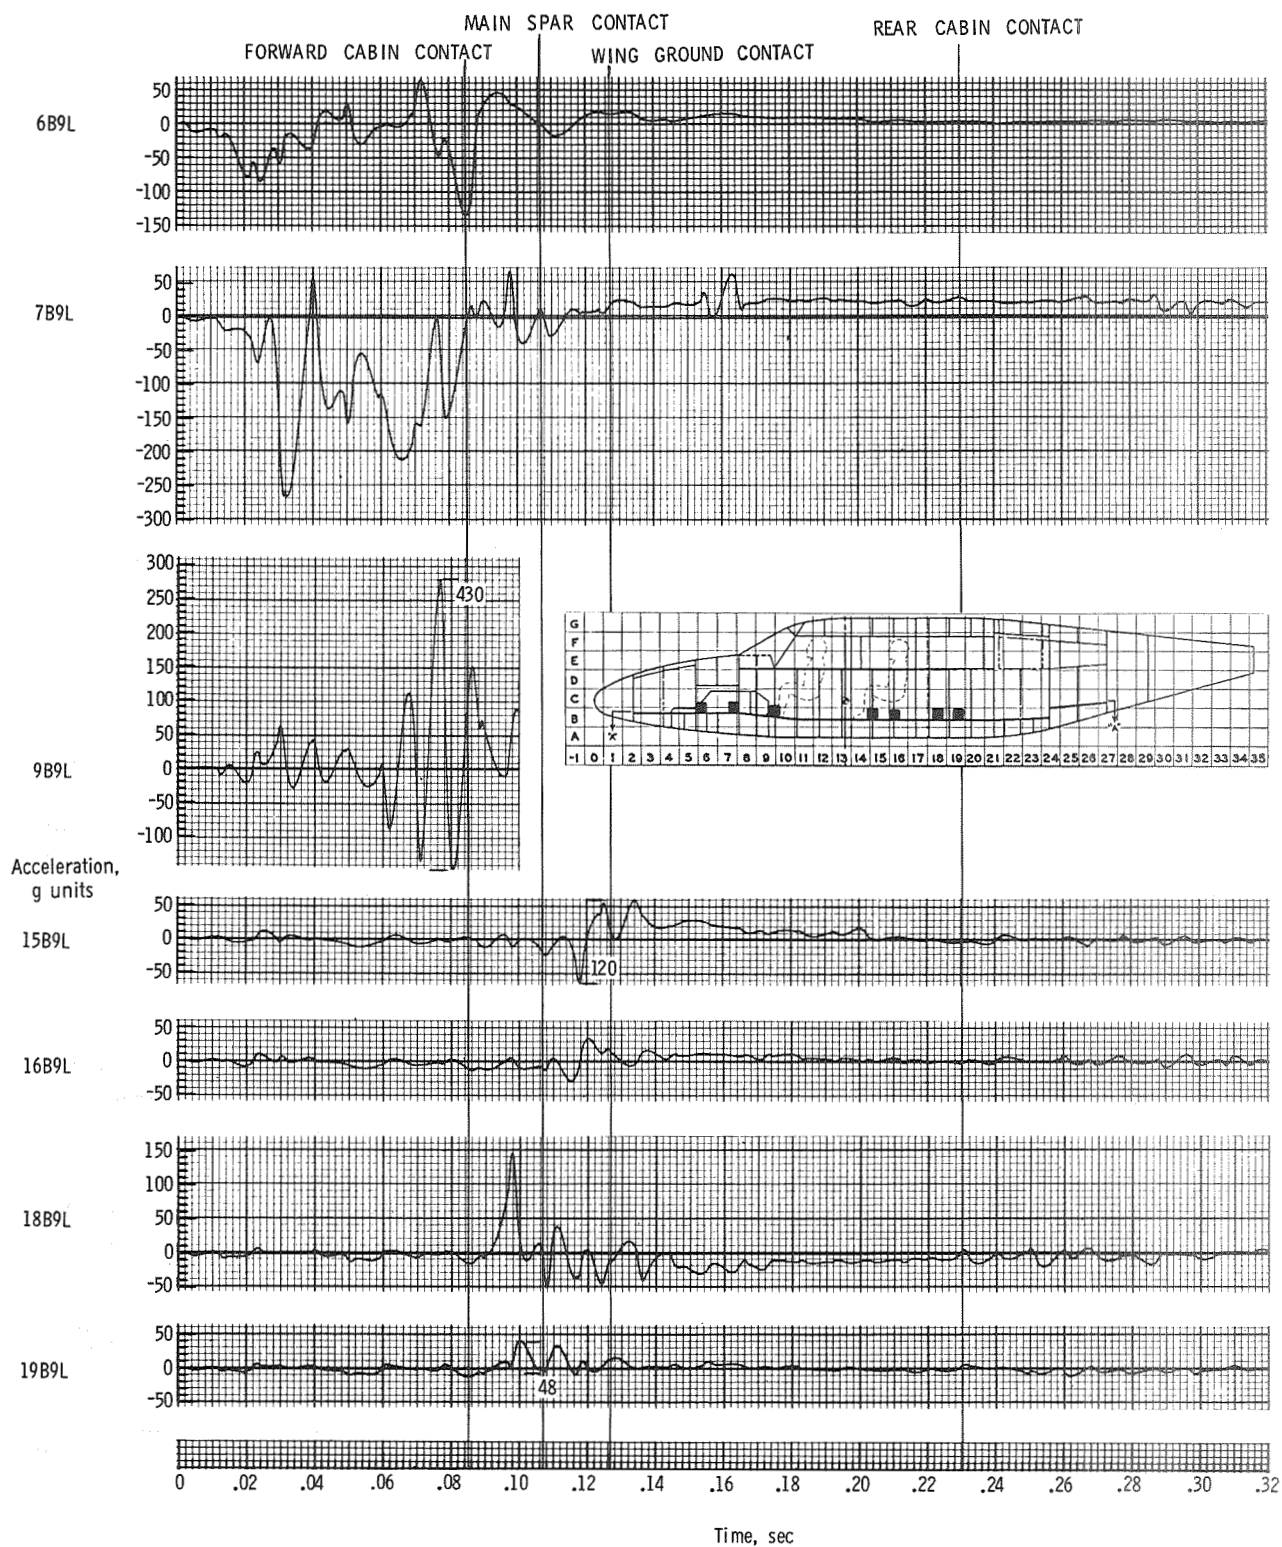
(b) -30° test specimen.

-30° test specimen.- There are seven longitudinal accelerometer locations along the floor beam in the -30° impact test. The additional accelerometer location 18B9L was added when a passenger and seat were placed in the third-passenger position (fig. 7). The longitudinal accelerations for the -30° test specimen are shown in figure 19(b). The accelerometer below the instrument panel (9B9L) shows a peak-to-peak acceleration 340 percent greater for the -30° test specimen than for the -15° test specimen. The longitudinal peak-to-peak accelerations in the cabin area (15B9L to 19B9L) show an increase of approximately 130 percent over the -15° cabin accelerations. The change in flight-path angle has much greater effect on the nose to fire wall portion of the airplane than in the passenger compartment. The third-passenger seat begins to deform, as determined from motion-picture data at wing ground contact.

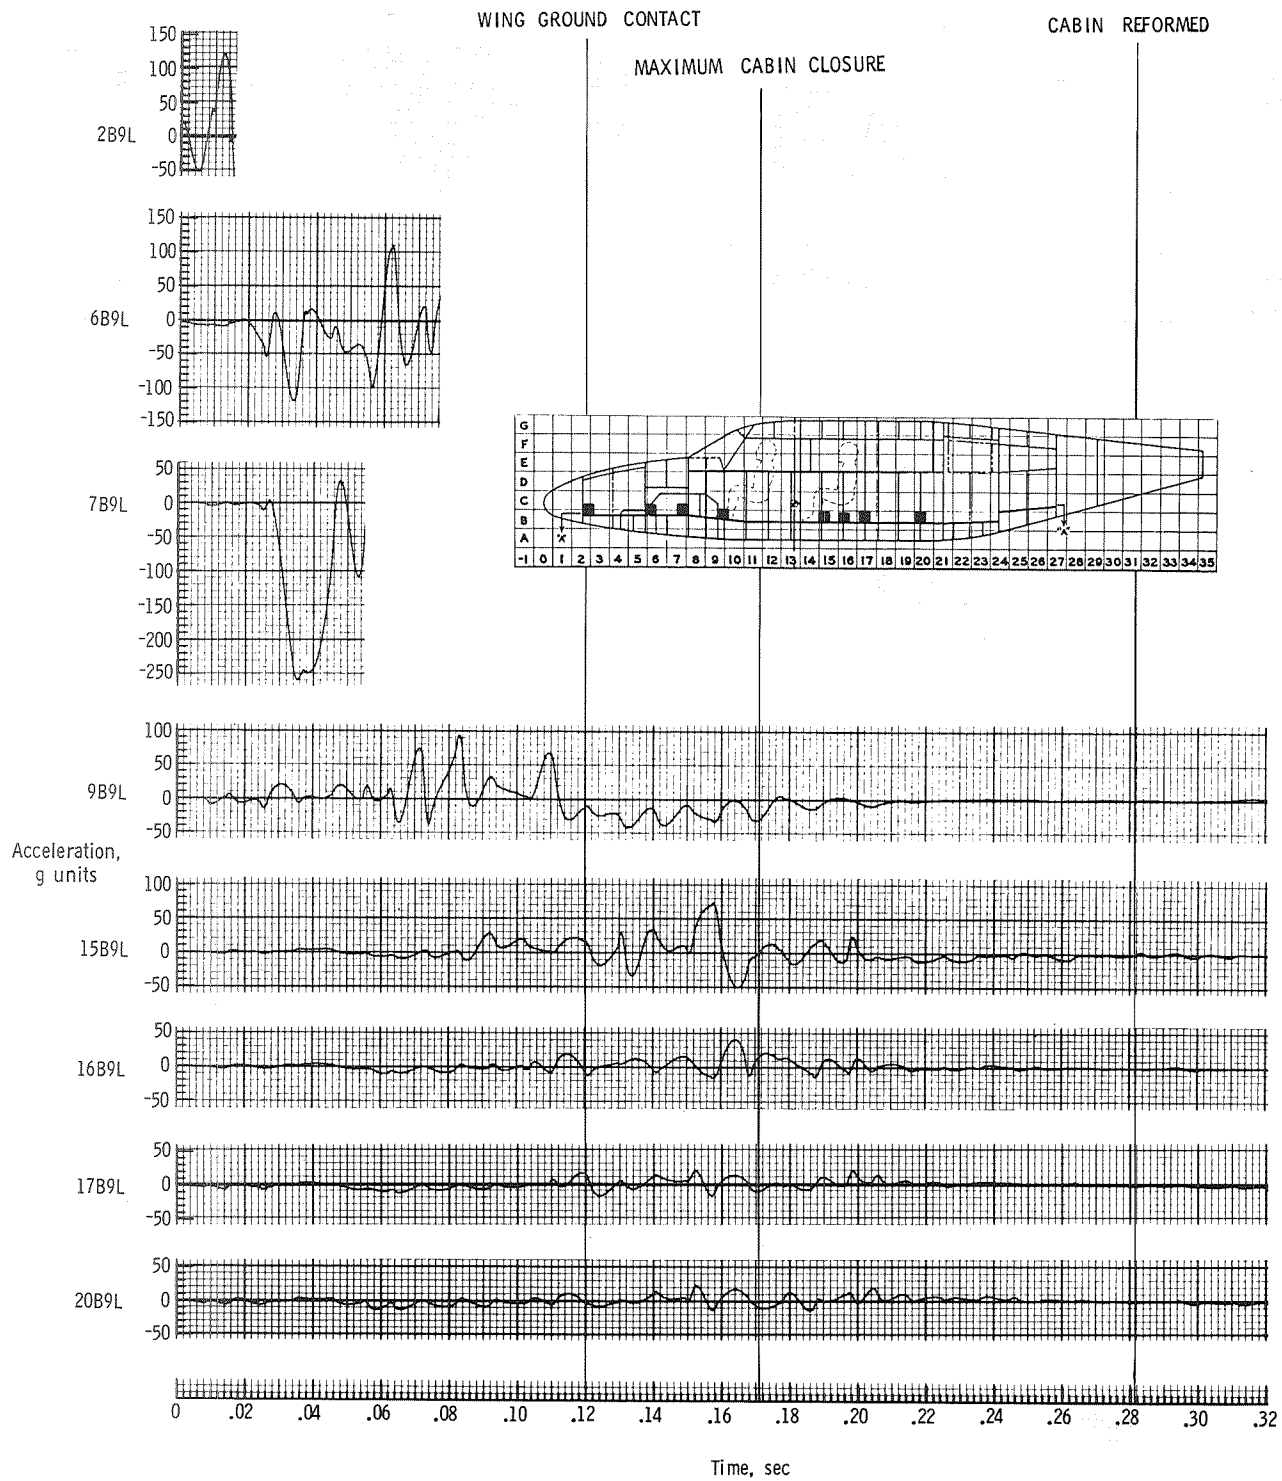
(c) -45° test specimen.

-45° test specimen.- In figure 19(c), eight longitudinal acceleration traces along the floor beam for the -45° test specimen are presented. The additional accelerometer location 20B9L was added when a passenger and seat

were placed in the third-passenger position (fig. 7). The magnitude of the longitudinal acceleration from the nose to the fire wall is about the same for the -45° test specimen as for the -30° test specimen. The longitudinal accelerations in the cabin area are also comparable to those of the -30° test specimen, thus indicating that severe structural deformations, which limit the magnitudes of the accelerations, are taking place. Also evident are inconsistencies in individual acceleration traces at approximately the same fuselage location - 9B9L and 18B9L at -30° and 9B9L and 17B9L at -45° - with much higher accelerations at -30° . These inconsistencies can be attributed to severe local structural failures changing the character of the local response. Wing ground contact at 0.120 sec to maximum closure of the cabin interior at 0.171 sec corresponds to the maximum longitudinal accelerations in the cabin interior with the maximum longitudinal acceleration occurring near maximum cabin closure (0.158 sec). After maximum cabin closure, the cabin began to reform as the airplane tail rotated to a horizontal position and continued its horizontal slide-out for approximately 30 m.

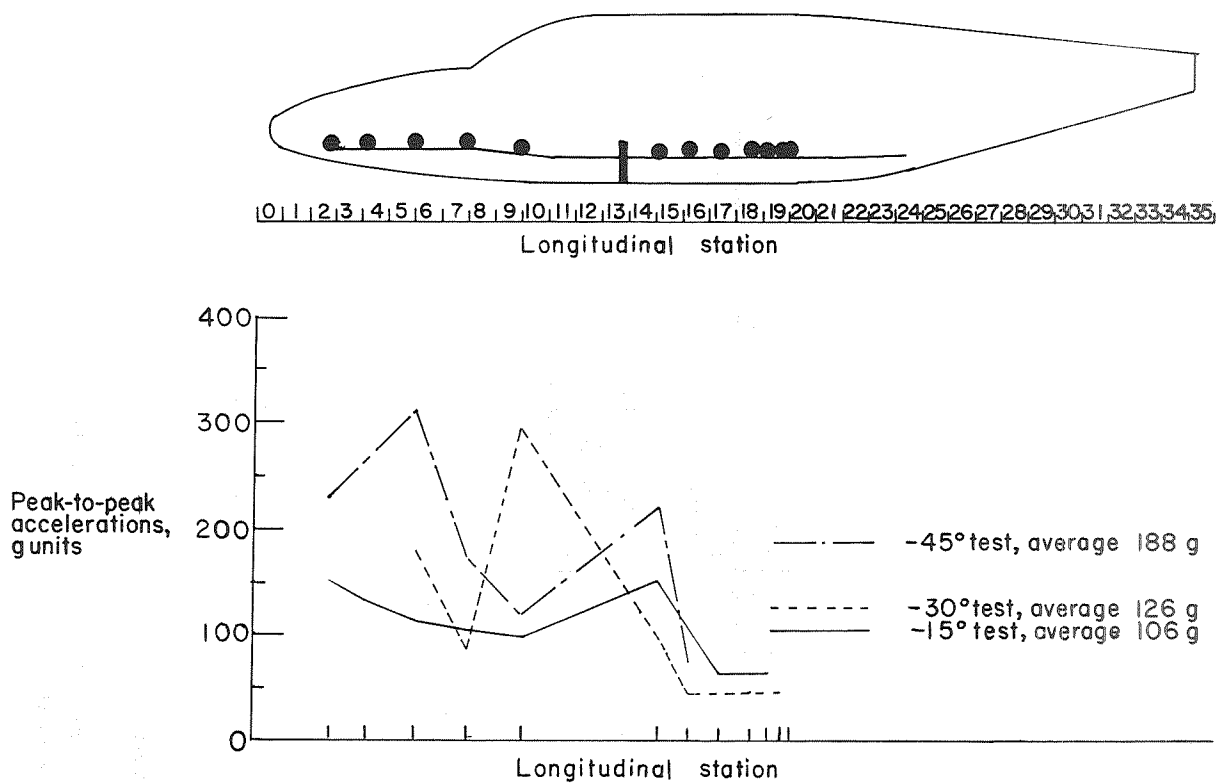
(a) Normal accelerations.

For the -15° test specimen, the normal peak-to-peak acceleration levels (fig. 20(a)) were more than twice the longitudinal acceleration levels (fig. 20(b)). This was due to higher decelerations in the normal direction when the airplane contacted the impact surface and abruptly stopped the motion in that direction. However, after initial impact in the longitudinal direction, the airplane skidded for some distance and then came to a stop; this long skid distance contributed to lower longitudinal deceleration forces. In figure 20(b) the longitudinal levels are shown to be nearly constant for the entire length of the floor beam, thus indicating little floor-beam deformation for the -15° test specimen but severe structural collapse and floor-beam deformations for the -30° and -45° test specimens. The effect of changes in flight-path angle

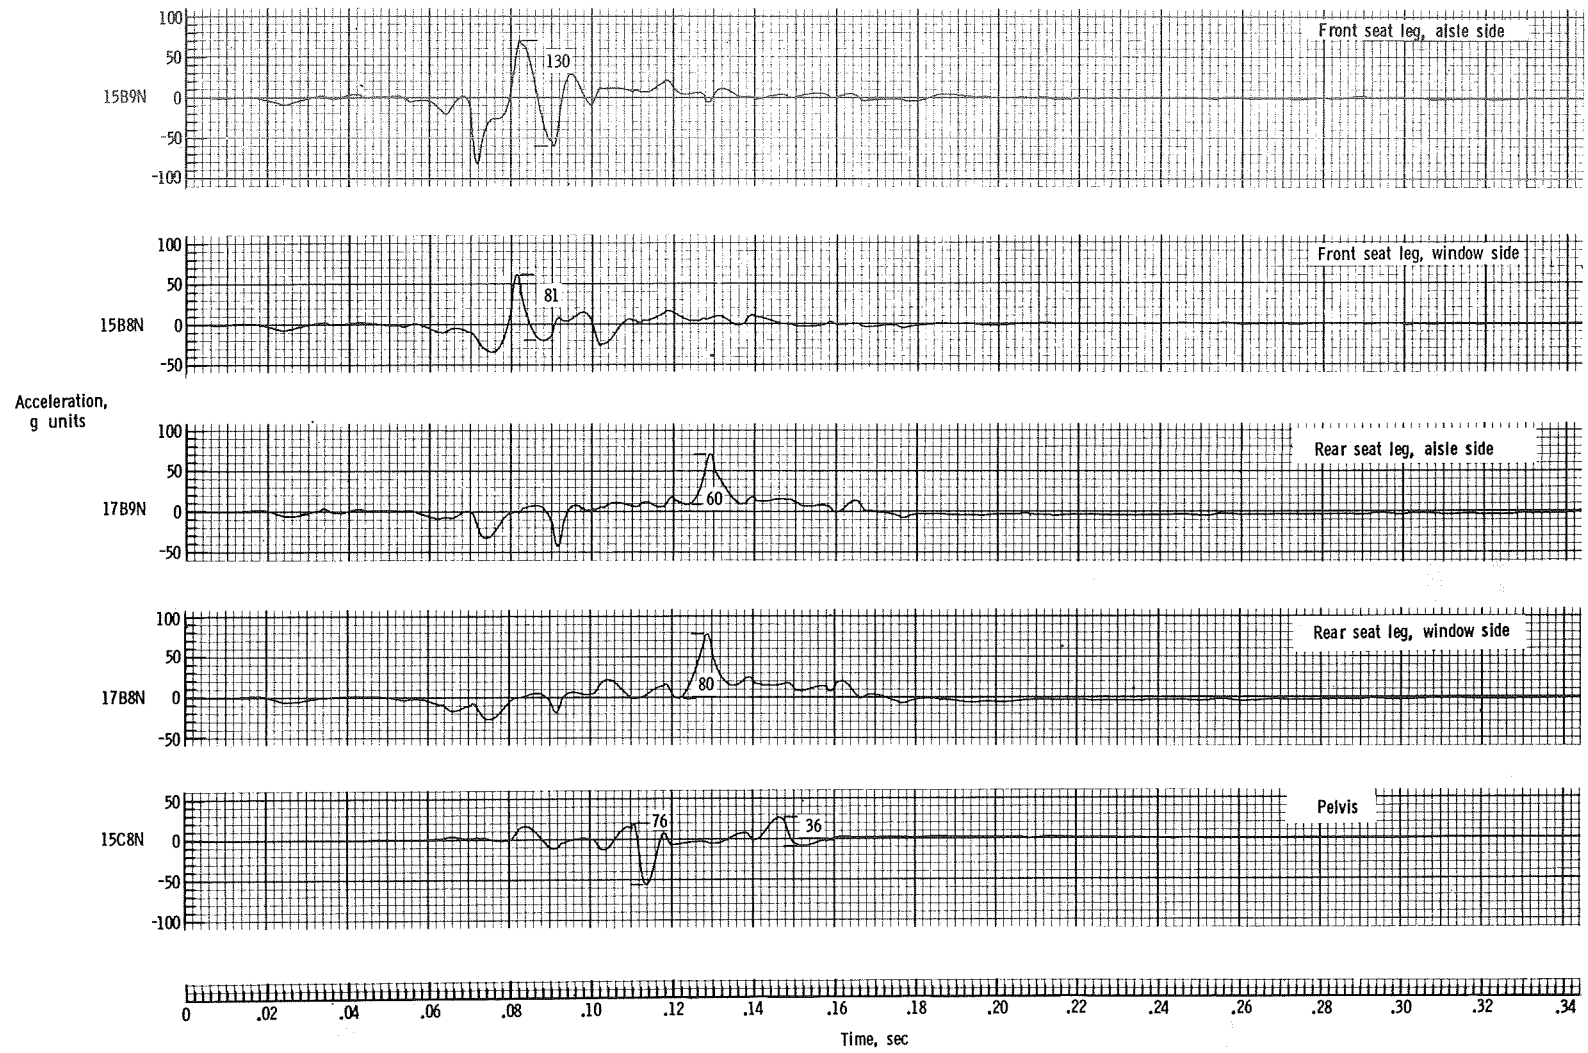
(a) -15° test specimen.

Normal accelerations at -15° . Figure 21(a) shows the normal accelerations for the -15° test specimen. Peak-to-peak accelerations of 130g and 81g were recorded on the floor under the two front seat legs at the first-passenger location, and accelerations of 76g (58 percent of 130g) were recorded in the pelvis approximately 0.025 sec later. The peak-to-peak accelerations under the rear seat legs were 60g and 80g and corresponded to a 36g pulse (45 percent of 80g) on the pelvis - again with a delay of approximately 0.025 sec.

Effects of normal accelerations. The pelvis peak-to-peak accelerations in the -15° , -30° , and -45° test specimens were 76g (fig. 21(a)), 40g (fig. 21(b)),

and 30g (fig. 21(c)), respectively. The 76g acceleration reflects the effect of cabin slapdown on the impact surface. A positive 60g peak-to-peak pulse was due to the effect produced by the dummy lifting off the seat against the restraint system. The 30g acceleration reflects the effect energy absorption plays in reducing load transmission. A greater total seat deformation was obtained in the -45° test specimen than was obtained in either the -15° or -30° test specimens. This situation suggests that accelerations experienced in aircraft crashes are limited by the eventual collapse of the surrounding structure. Unfortunately, this structural collapse may also be accompanied by the loss of a livable volume within the cabin area, affecting the survivability of the occupant. In a crashworthy design, the structural collapse would be controlled to produce maximum energy absorption and still maintain livable volume in the cabin.

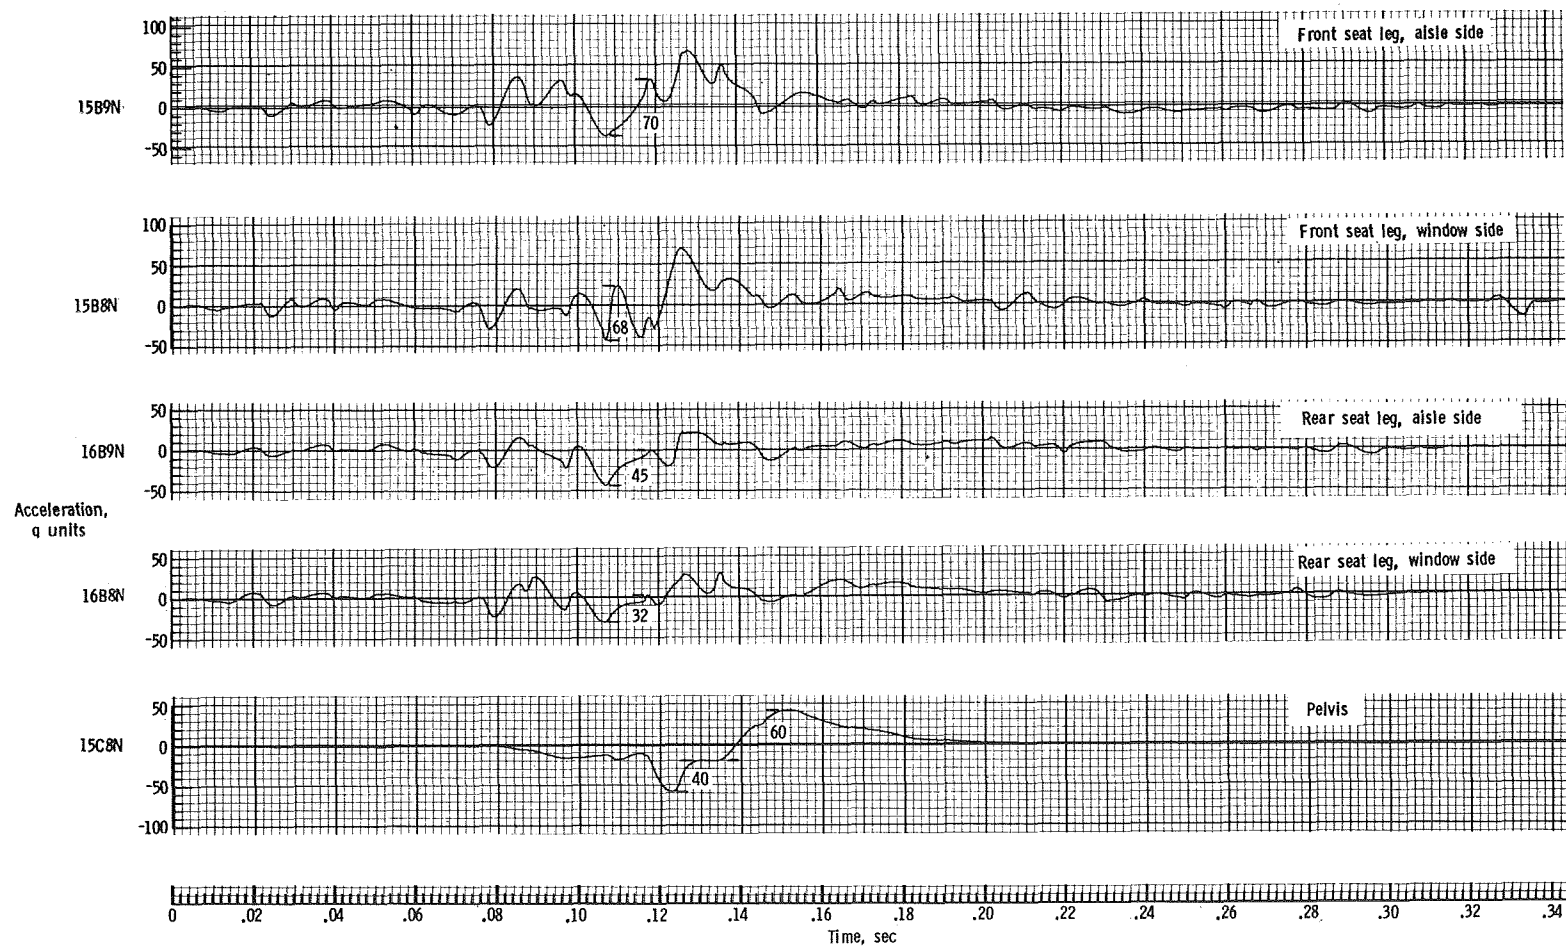
(b) -30° test specimen.

Normal accelerations at -30° . Figure 21(b) shows the normal accelerations for the -30° test specimen. Peak-to-peak accelerations of 70g and 68g were recorded on the floor under the two front seat legs and 45g and 32g under the two rear seat legs. The acceleration on the pelvis was recorded at 40g (15 percent of 70g) approximately 0.02 sec later.

The -30° test specimen was the only one in which the restraint system of the first passenger was instrumented with load cells. The positive (downward) peak-to-peak accelerations of 60g (fig. 21(b)) in the pelvis corresponded to a 5.3-kN tensile force in the shoulder harness (see appendix fig. A3(f)) when the occupant's relative motion with respect to the seat was stopped by the restraint system.

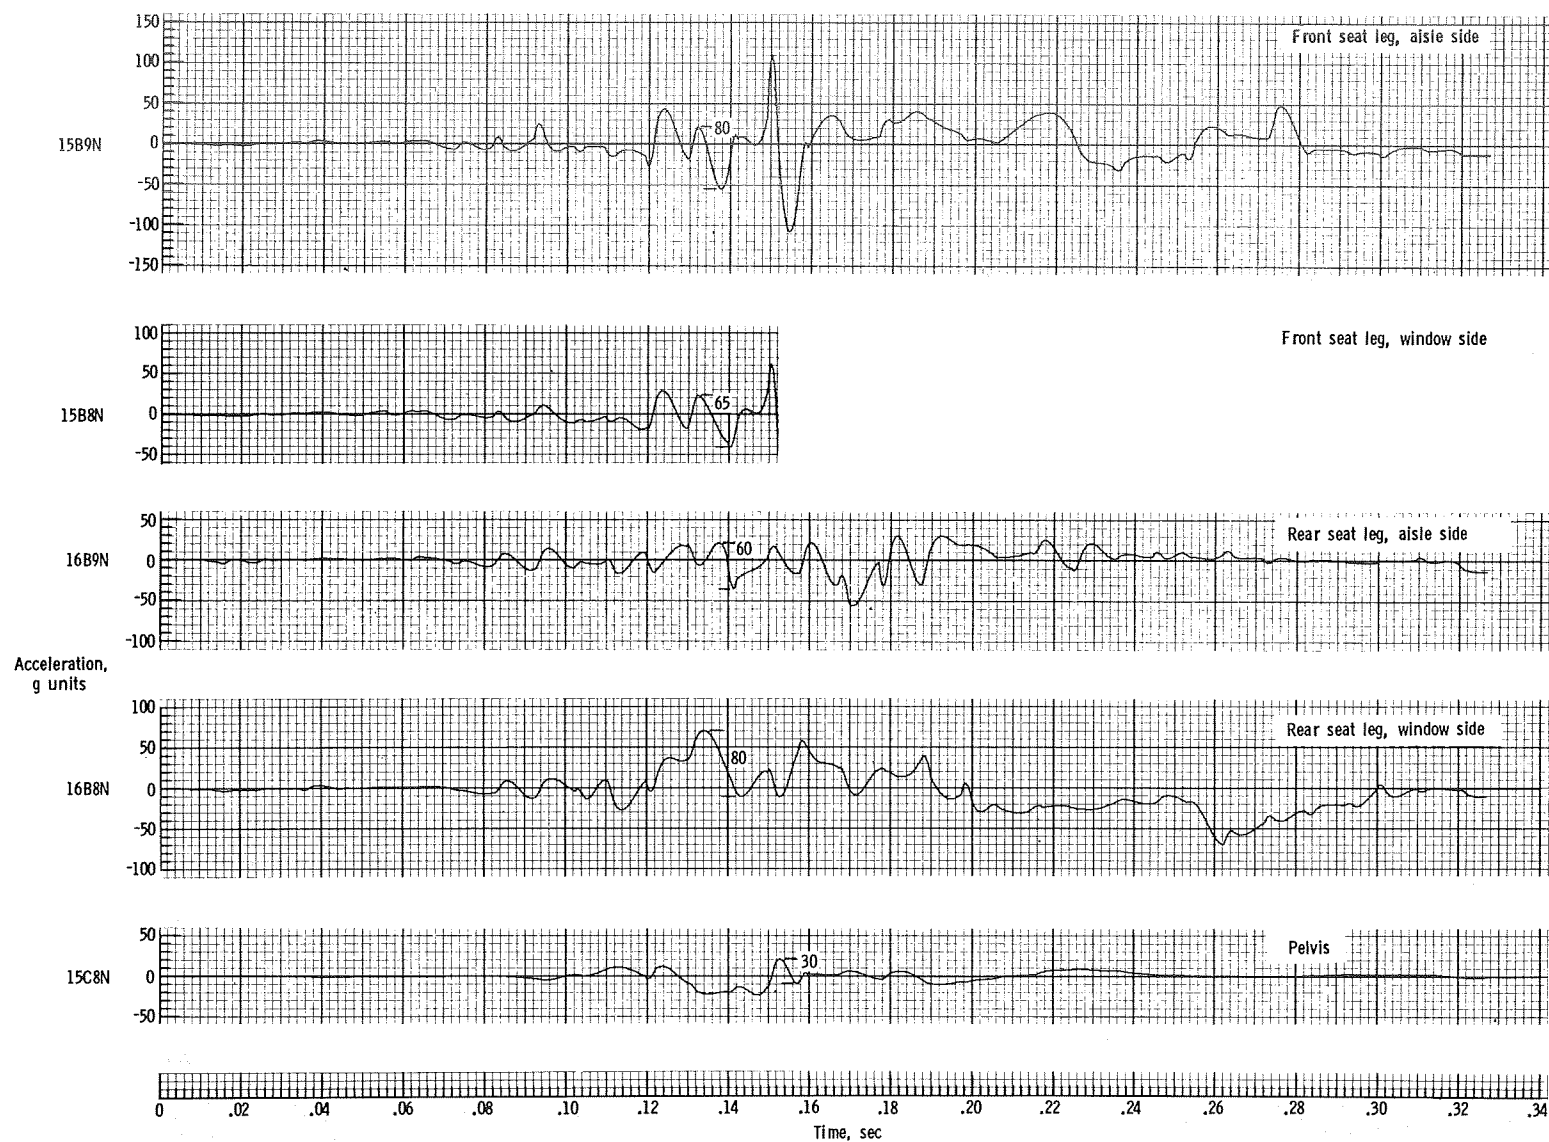
(c) -45° test specimen.

Normal accelerations at -45° . Some unusual airplane crash behavior was exhibited by the -45° test specimen during impact. First, the nose of the airplane impacted and crushed progressively to the fire wall while the remaining portion of the fuselage maintained its -45° flight-path angle, thus eliminating the livable volume in the cabin. This behavior was followed by a downward rotation and a reforming of the fuselage immediately thereafter. The resulting accelerations (fig. 21(c)) on the floor and in the pelvis of the first passenger lacked the smoothness and well-defined pelvic pulse of the -15° and -30° test specimens. Nevertheless, peak-to-peak accelerations on the floor were 80g and 65g next to the front seat legs and 60g and 80g next to the rear seat legs. The peak-to-peak acceleration on the pelvis was 30g (38 percent of 80g), which occurred at about 0.015 sec later. The seat deformed, absorbing some of the impact energy and reducing the pelvic accelerations.

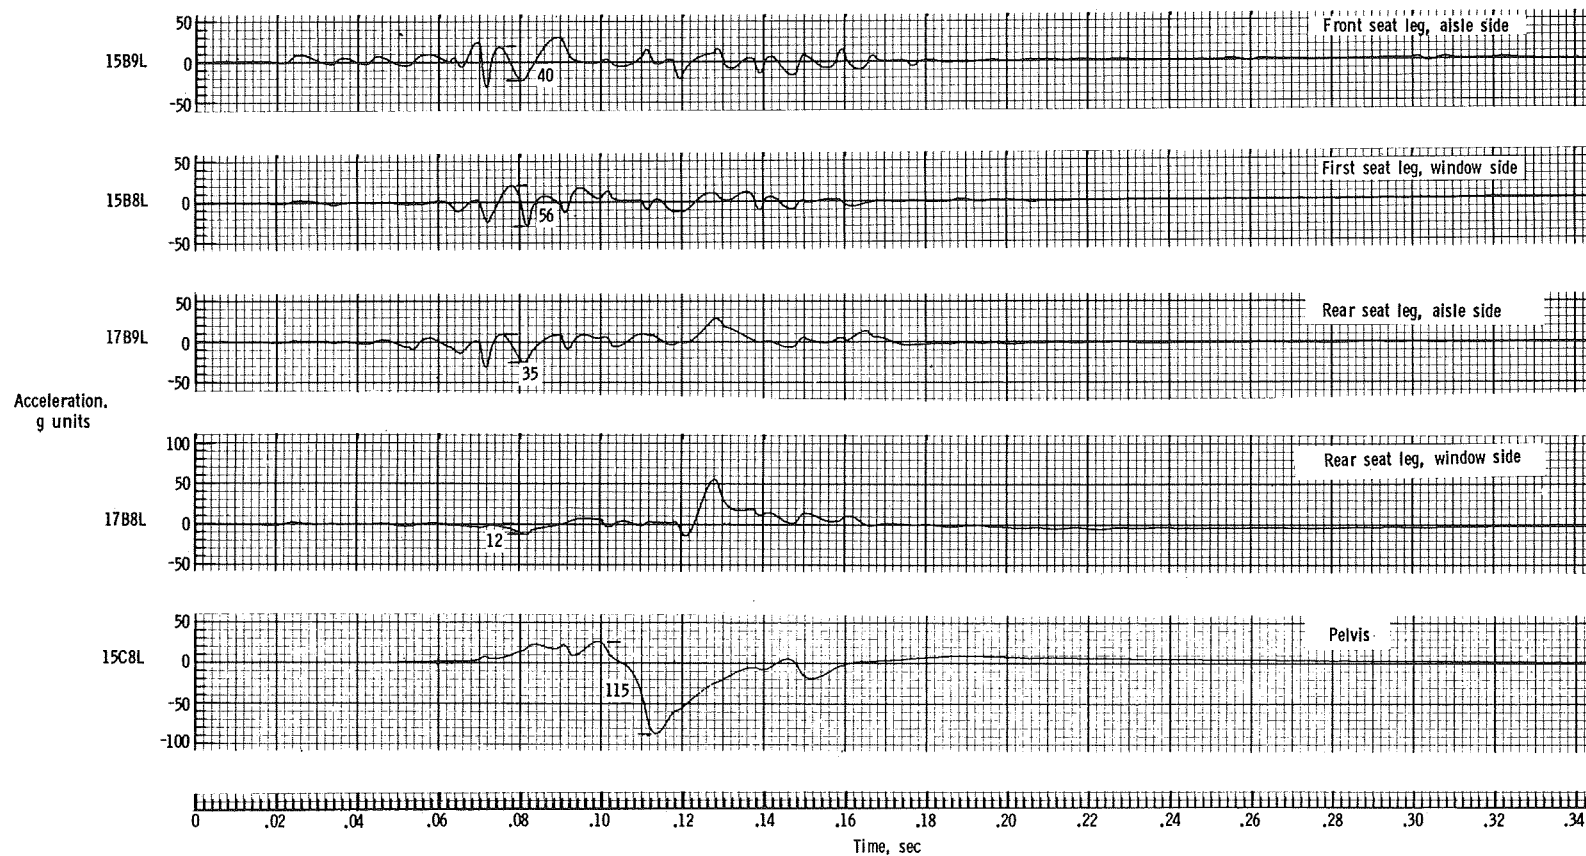
(a) -15° test specimen.

Longitudinal accelerations at -15° .— As shown for the -15° test specimen in figure 22(a), longitudinal peak-to-peak accelerations of 40g and 50g were recorded adjacent to the front seat legs and 35g and 12g adjacent to the rear seat legs. These acceleration pulses were recorded in the pelvis with a peak-to-peak value of 115g occurring 0.025 sec later.

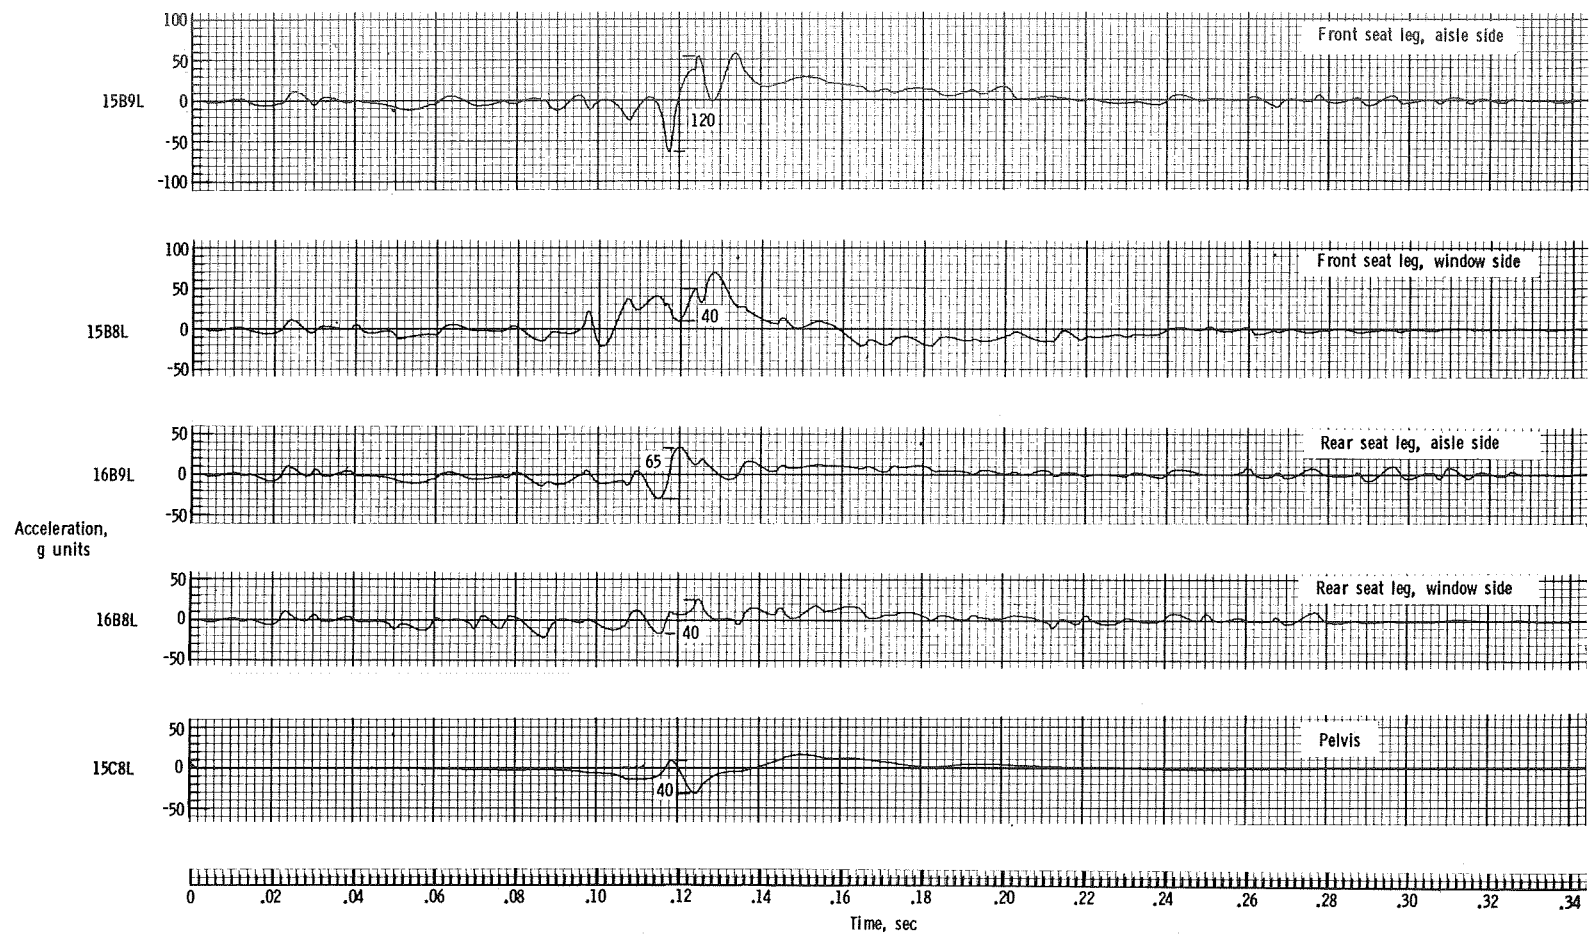
(b) -30° test specimen.

Longitudinal accelerations at -30° .— As shown for the -30° test specimen in figure 22(b), longitudinal peak-to-peak accelerations of 120g and 40g were recorded on the floor adjacent to the front seat legs and 65g and 40g adjacent to the rear seat legs. These peaks were recorded in the pelvis as a 40g peak-to-peak pulse occurring 0.025 sec later.
